Les Slimes

Newsletter of South Downs Escargots (www.southdownsescargots.co.uk/)
Member group of 2cvGB Articles and 2cv news always welcome.
Please send copy and pics to John Chaplin (biker1@btinternet.com)

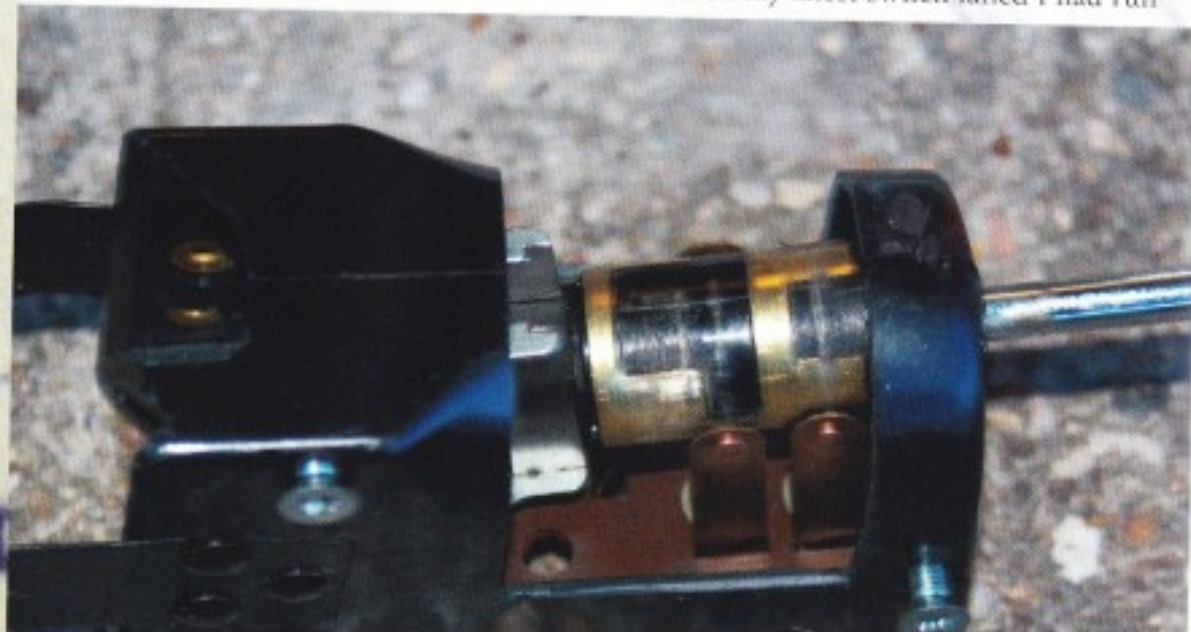
Like many of us I have collected numerous 2cv light switches over the years. I have at least six in my 'might be useful one day' box, none of which work in all switch positions. I have always run on 100W halogen headlamp bulbs and assumed the regular failure of the switches was an occupational hazard of not using a relay to cope with the extra current. I had tried cleaning up the brass ferrules on the rotating part of the switches at various times, even though no burn marks were apparent, but this only seemed to solve the problems temporarily - and I now realise coincidentally too!

1. When the switch is rotated to the first position (dipped-beam and side-lights or side-lights only) and the lever is pulled towards you, the side-lights don't come on. Not usually a disaster as you are probably driving in twilight and can quickly flick back to the dipped beam position.

2. When the switch is rotated to the second position (dipped-beam and side-lights or main-beam and side-lights) and the lever is pulled towards you, both the side-lights and main beam fail to come on leaving you with no lights at all. Much more dangerous as you are now almost certainly driving in the dark and although flicking back to dipped beam usually works, for those few seconds you have been driving completely blind

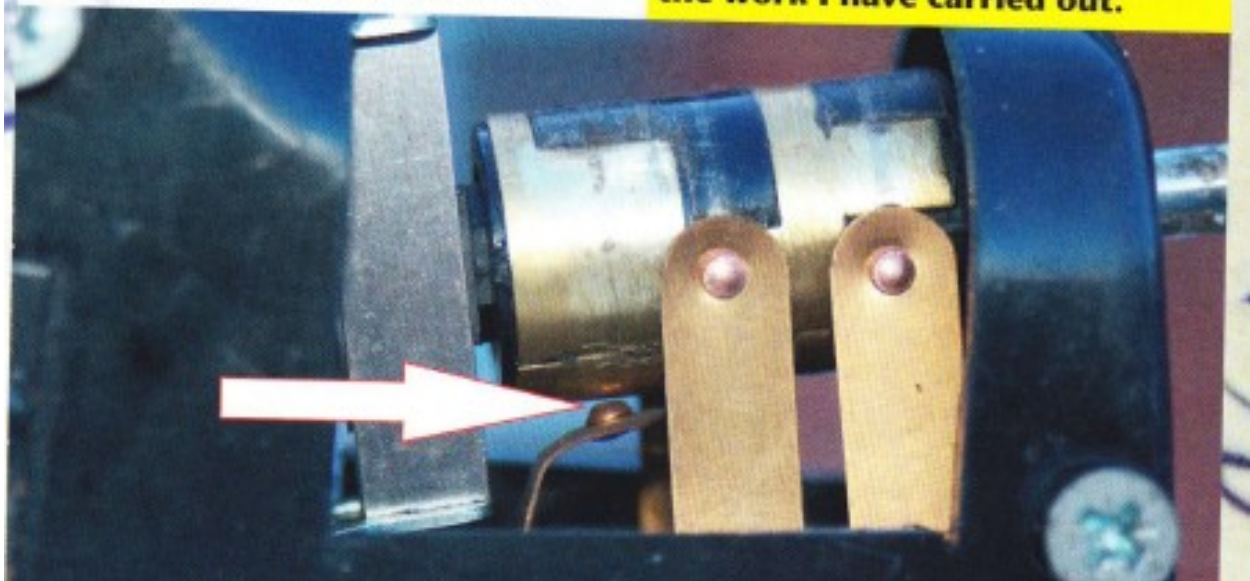
out of useable spare ones, so I was forced into investigating what actually went on inside the faulty switches. I made up a simple testing jig by cutting an access hole in the top of a switch which had a broken casing anyway (see *photo*). This enabled me to see exactly what was connected to what at each switch position and what happened when the lever was moved backwards and forwards.

Substituting the innards of a faulty switch into my 'jig' it seemed that the three springy contacts I could see were following the brass ferrule correctly, but a meter confirmed that there was no feed to the main-beam or side-light terminals with the stalk pulled up. Only when I turned the switch over did I realise there was a fourth contact tucked underneath and sure enough (as you can see in the second photo) when I held it up to the light I could see fresh air between the contact and the ferrule. Yesssss!! One of those rare 'Eureka' moments. Turns out that this contact is the main feed into the

switch and with a gap there nothing can possibly come out.

From then on the cure was easy. Quick tweak of the springy bit with the long-nose pliers, problem sorted and three months later it is still working fine – as are the other five switches that have come out of hibernation. If you are going to attempt this yourself it is worth bearing in mind that I did it off the car and you don't actually need to make a jig to do the repair. It would also be possible to do it in situ but make sure you disconnect the battery – long-nosed pliers in amongst live electrics are not a good idea.
